# IDENTIFYING POTENTIALLY DANGEROUS ELECTRICITY INFRASTRUCTURE TO BALKAN POPULATION OF EGYPTIAN VULTURE AND MITIGATION MEASURES (2012 - 2015)

## TECHNICAL REPORT UNDER ACTION A6

**LIFE+ PROJECT  
"THE RETURN OF THE NEOPHRON"  
LIFE10 NAT/BG/000152**

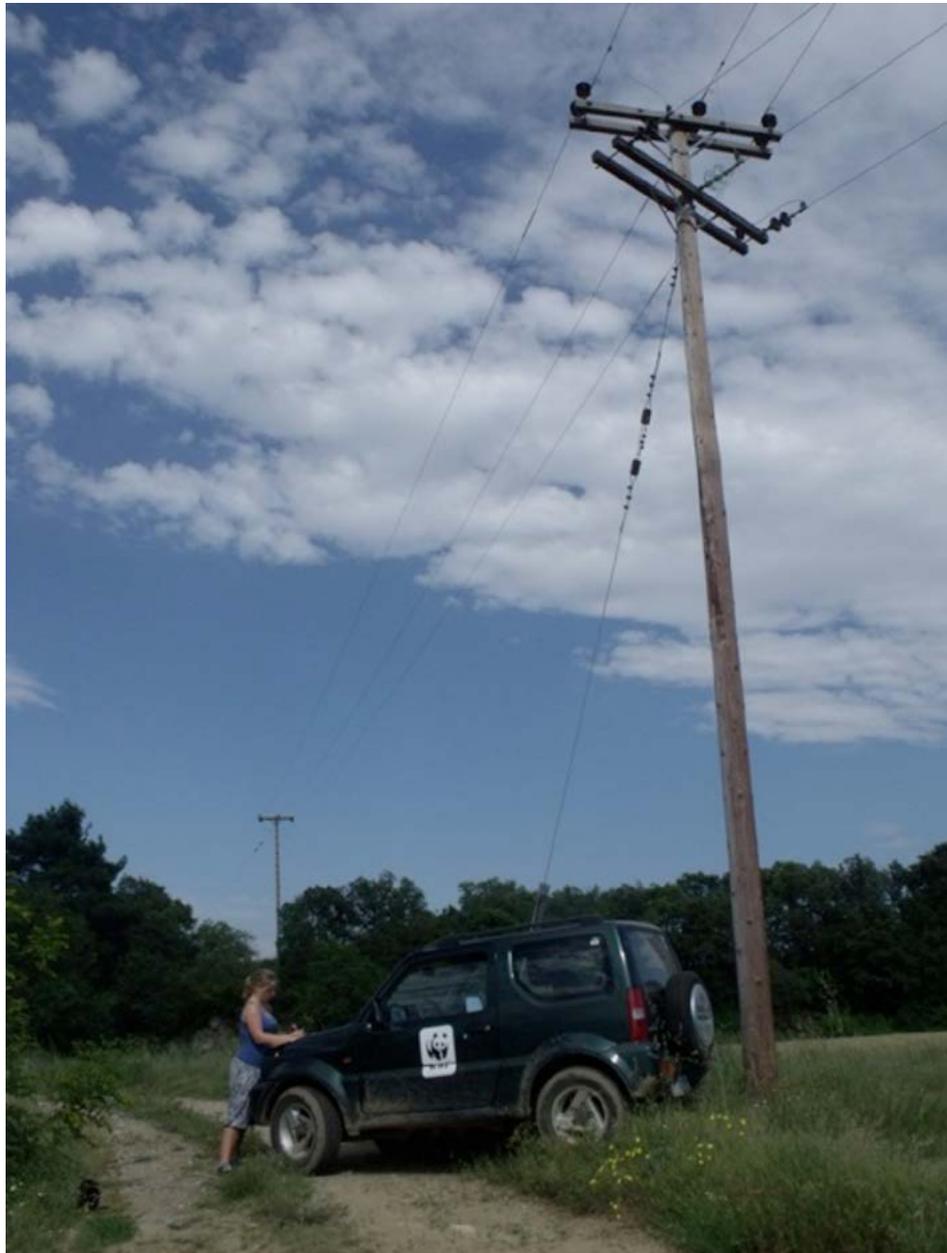
**Figure 2.** Fieldwork for identification and mapping of dangerous electricity pylons nearby Egyptian vulture nests. Photography: WWF Greece /J. Gracia.

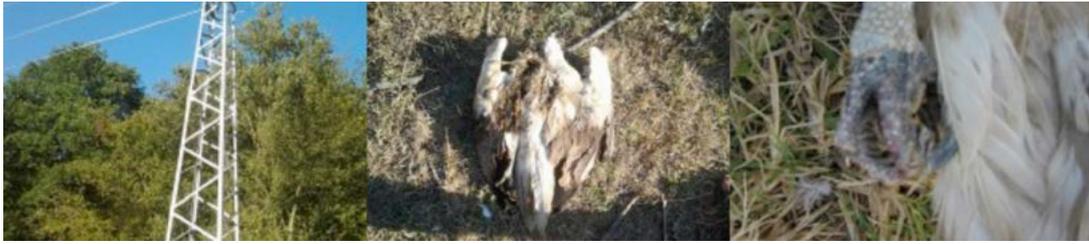
**Figure 3.** *Electrocuted Egyptian vulture found in Eastern Rhodopes, Bulgaria in 2012. Photography: BSPB/S. Mumun.*

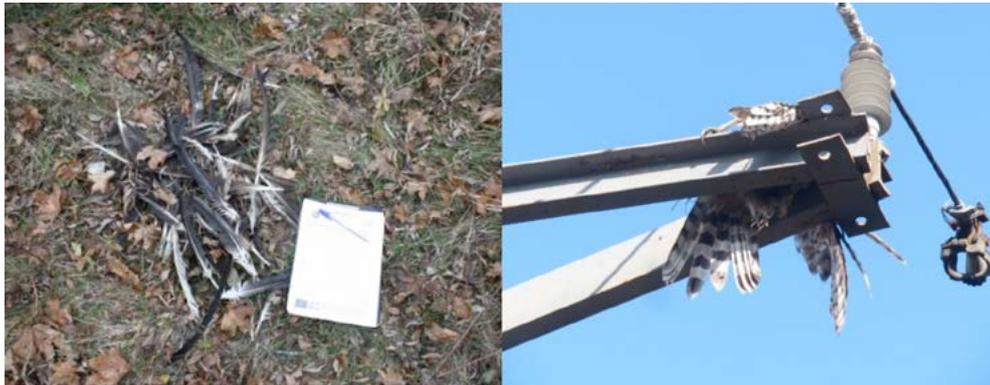
**Figure 4.** *Electrocuted White stork (left) and Goshawk (right). Photography: BSPB/G. Gerdzhikov.*

A total of 112 dead birds were found under the mapped pylons and power lines in Bulgaria, of which 85 (75.9%) had died from electrocution and 27 (24.1%) from collision. Only one Egyptian vulture (subadult) was found electrocuted during the regular monitoring of the breeding territories (BSPB 2012, **Figure 3**). The 112 carcasses found belonged to the following species: White and Black stork (47%), Golden eagle, Short-toed eagle, Common buzzard, Goshawk, Sparrowhawk, Common kestrel (18%), Passeriformes (25%, out of which corvids 11%), Tawny owl and Eagle owl (4%), other (6%) (**Figure 4**).

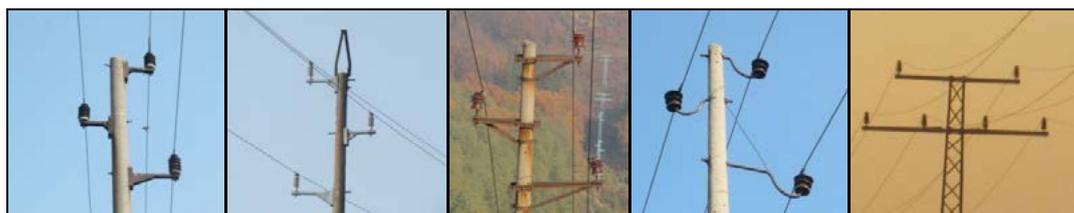
Critical Type of pylons (Cr) – metal, wooden, concrete pylons with different number of crossbars and insulators directed up;

Cr1

Cr2

Cr3

Cr4

Cr5

1.1. Concrete pylons. Insulators are located on 1, 2 or 3 crossbars at staggered intervals from the top of the pylon. The insulators are directed up (**pin-type**), often the higher insulator is above the top of the pylon (see the photos of pylons types: **Cr 1, 2, 3, 4**). When there are more than three insulators, they are more often located on two crossbars always directed up (see the photos of pylons type: **Cr 6**). In some cases there are concrete pylons with three insulators directed up and located on only one crossbar (see the photos of pylon types: **Cr 8, 9**).

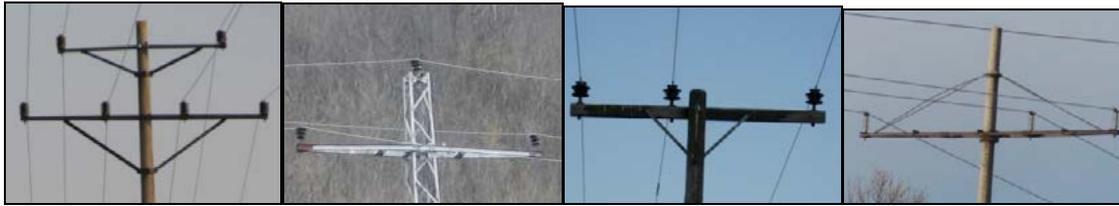
Cr6

Cr7

Cr8

Cr9

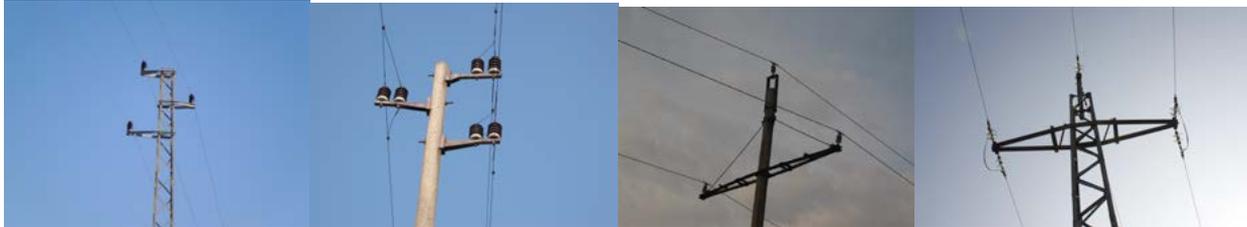
Cr10

Cr11

Cr12

Cr13

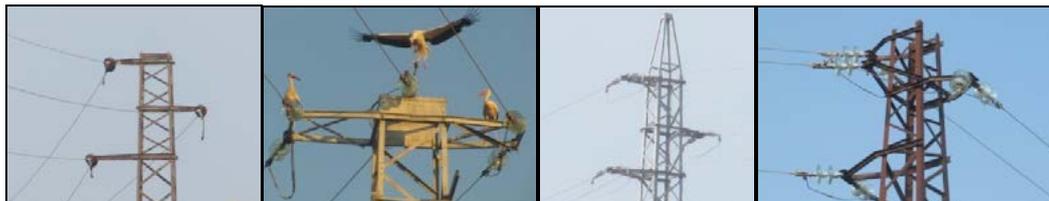
Vulnerable type of pylons (Vu) - metal, wooden, concrete pylons with different number of crossbars and insulators located laterally;

Vu1

Vu2

Vu3

Vu4

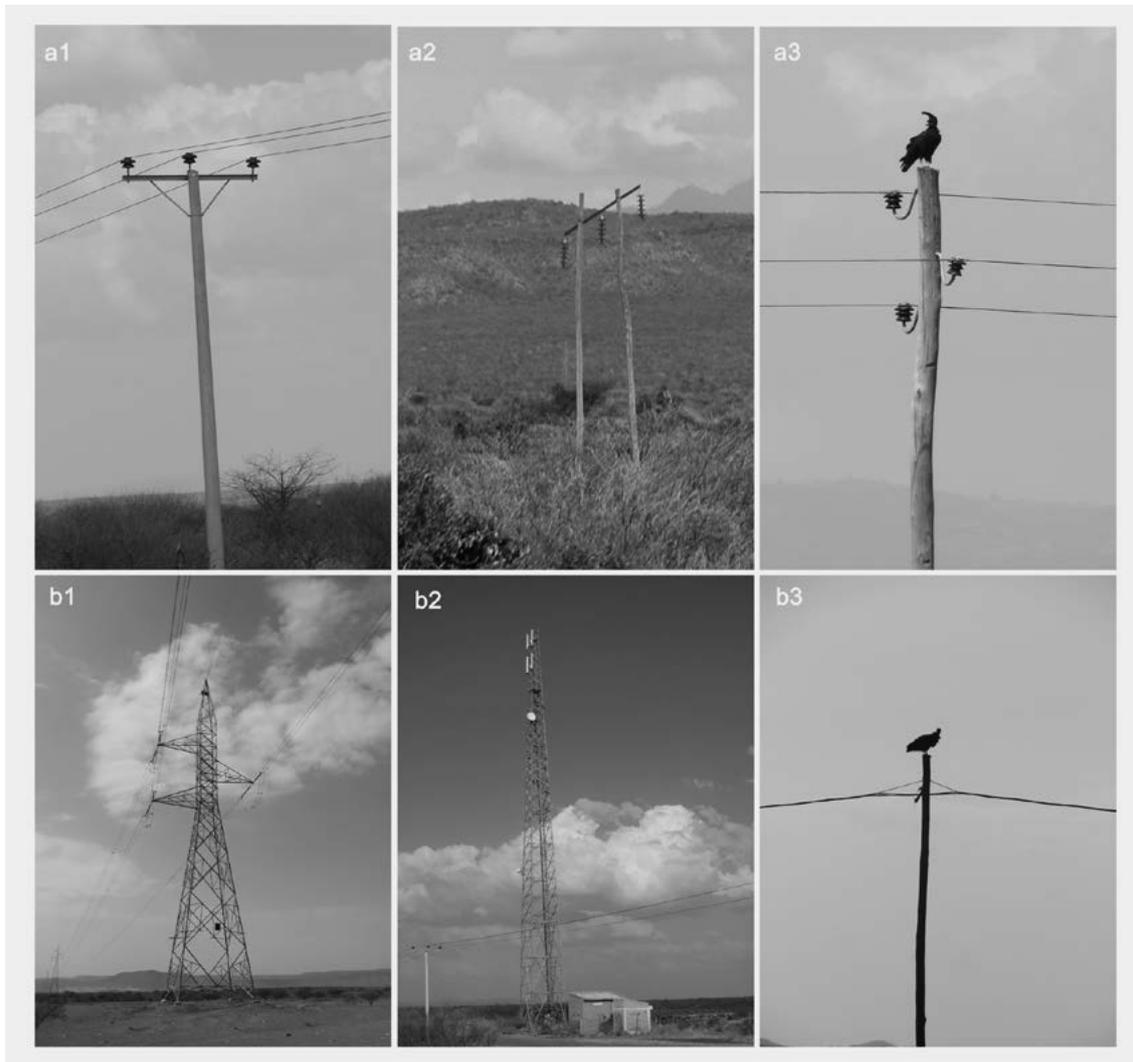
**Annex IV.** Types of roosting pylons for Egyptian vultures in Afar, Ethiopia

(a) Dangerous type, including: (a1) low voltage T-shaped poles, (a2) low voltage  $\Pi$ -shaped poles, (a3) low voltage I-shaped, and (b) Safe type, including: (b1) high voltage A-shaped poles, (b2) communication tower, and (b3) poles without wires.

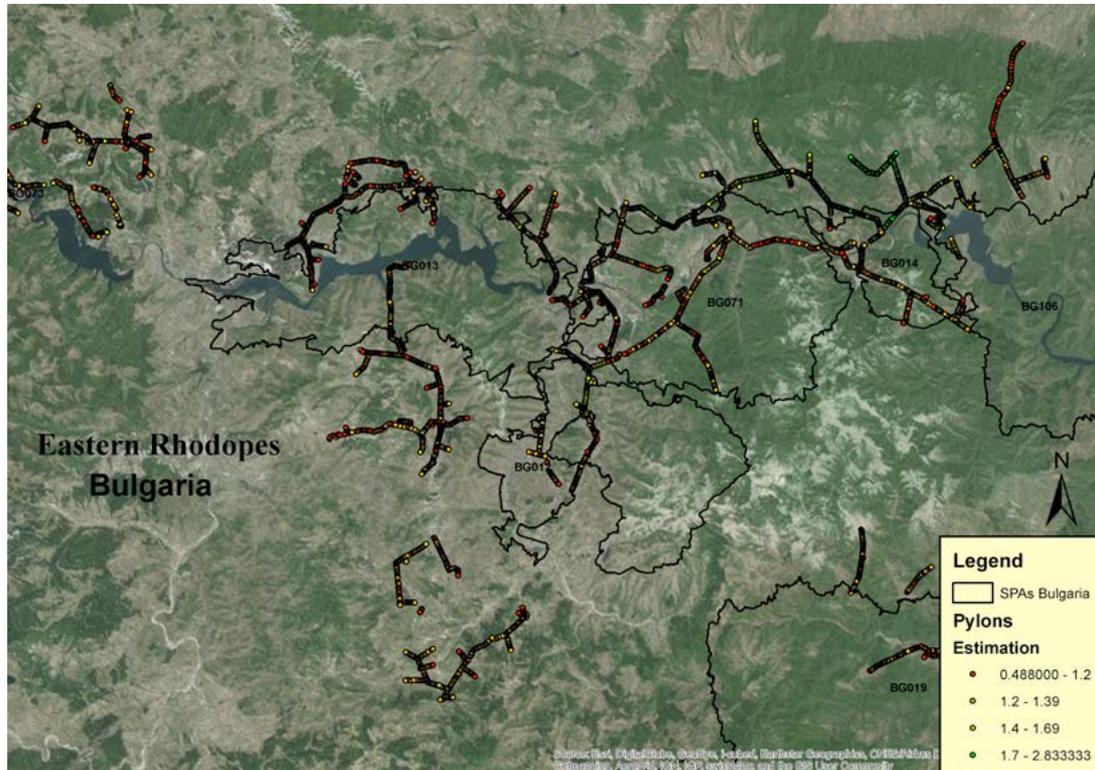
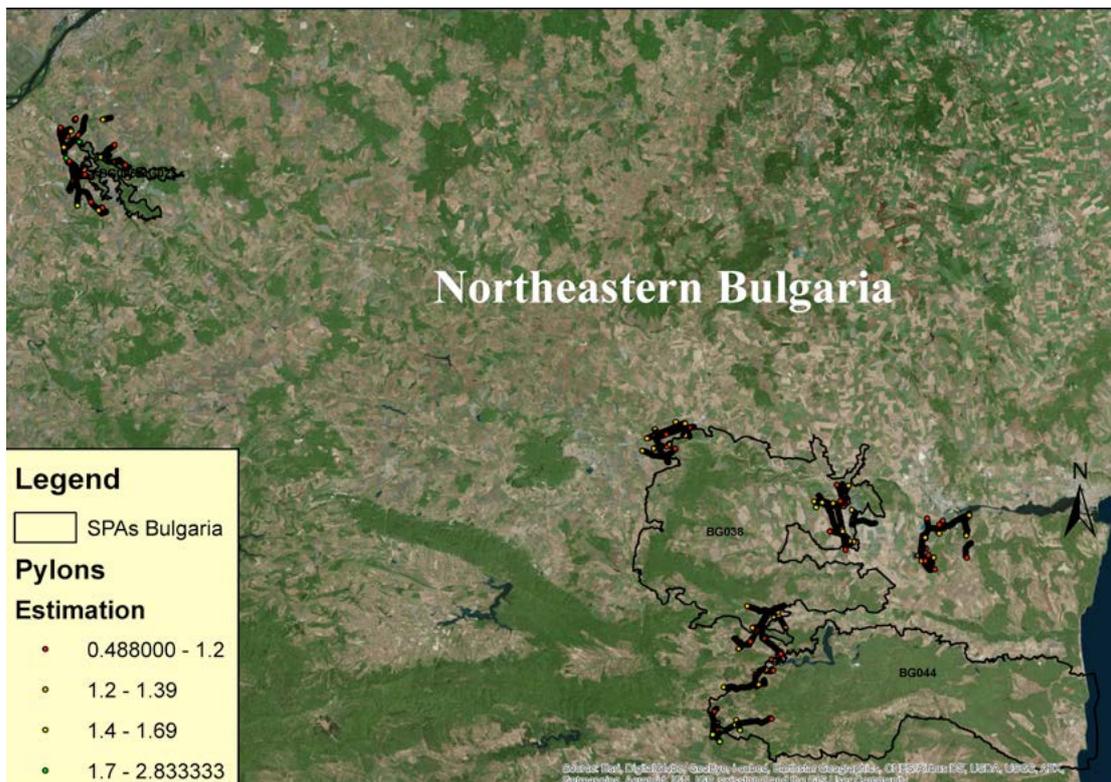
**Annex V.** Sensitivity maps for the risk of electrocution of Egyptian vultures in Bulgaria and Greece

Maps refer to the breeding grounds in Eastern Rhodopes (Bulgaria and Greece), Northeastern Bulgaria, Northern and Central Greece (green = low risk; yellow = medium risk; orange = high risk and red = very high risk; for the values of the categories see Methods).

A set of sensitivity maps for the risk of electrocution of Egyptian vultures in the breeding grounds in Bulgaria and Greece were produced (**Annex V**).
